## Cracks in Oven Roof.

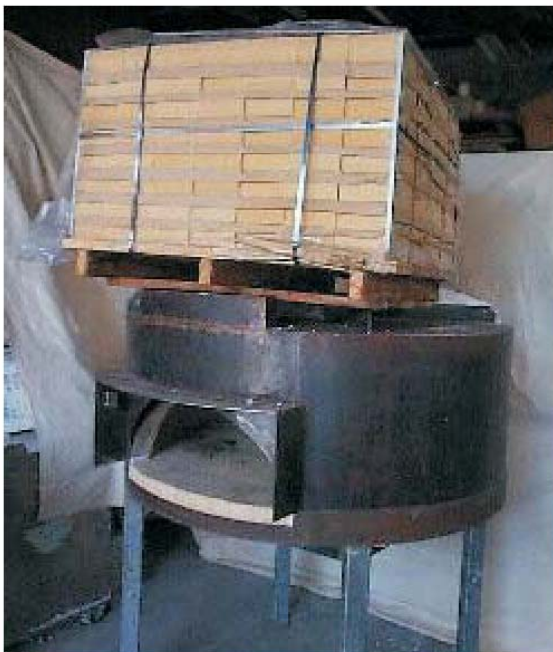
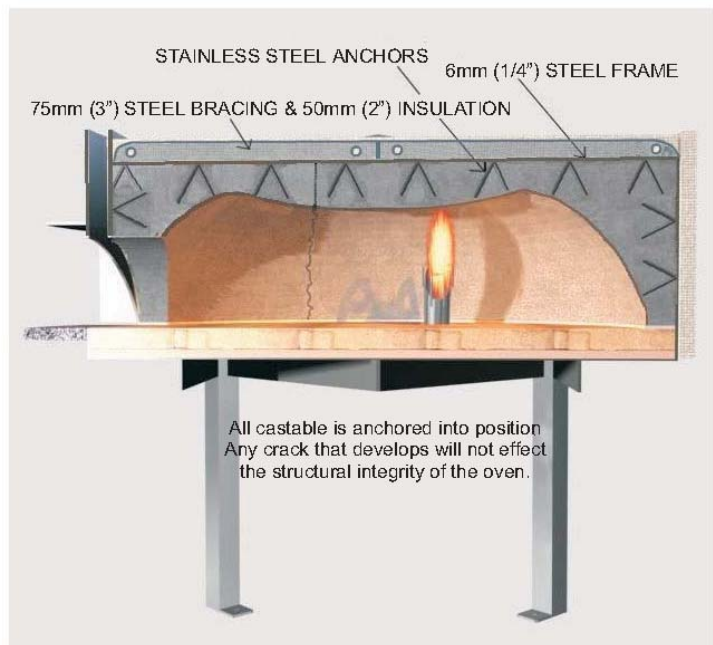
As seen in the pictures below the Doughpro Oven is strong, solid and dependable.
