Flue Fire Prevention Awareness

Introduction

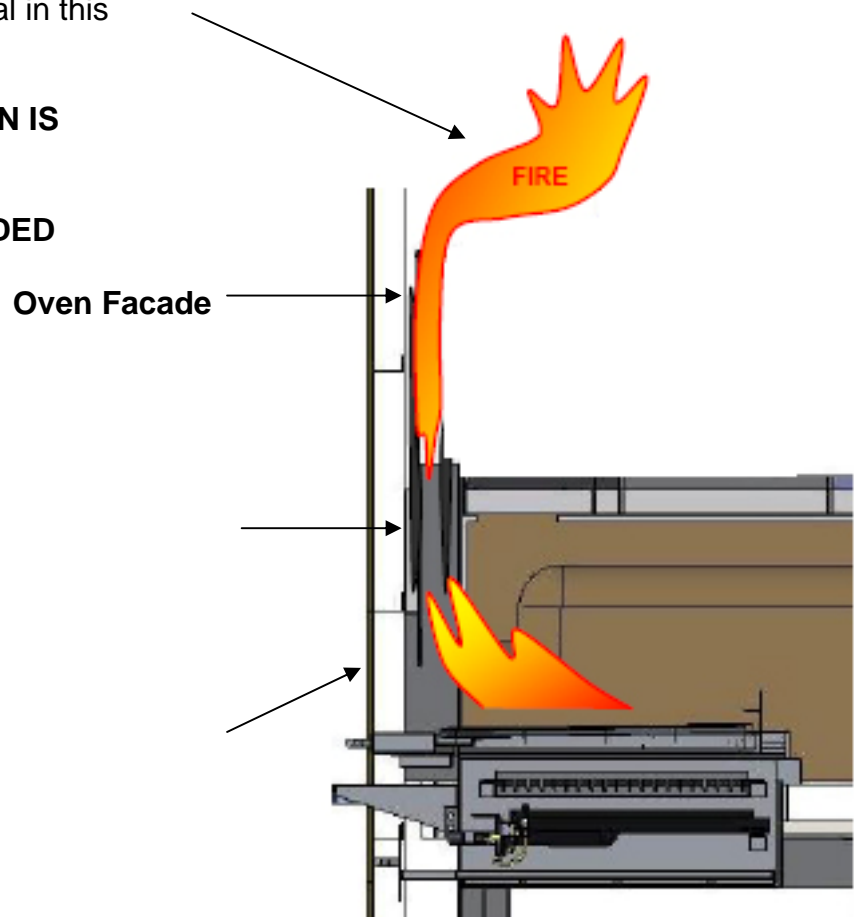
2. Potential cause of fire behind the façade

Poor sealing between the façade and oven door leads to grease contamination between façade and oven wall. This grease contamination is then ignited by a flash fire off the grill.

B. The fire, fuelled by a residual build up of grease, is drawn into the area above the oven igniting any flammable material in this area.

A. Grease build up between the façade and spigot ignites from flash fire on Char Grill

THE AREA BETWEEN THE SPIGOT AND THE FAÇADE MUST BE SEALED WITH A FIREPROOF MATERIAL E.g. METAL STRIP

Solution: Ensure that the area above the oven door and façade is fully sealed with a fire proof material.

IT IS ESSENTIAL THAT THE OVEN IS INSTALLED CORRECTLY IN ACCORDANCE WITH THE INSTALLATION MANUAL PROVIDED

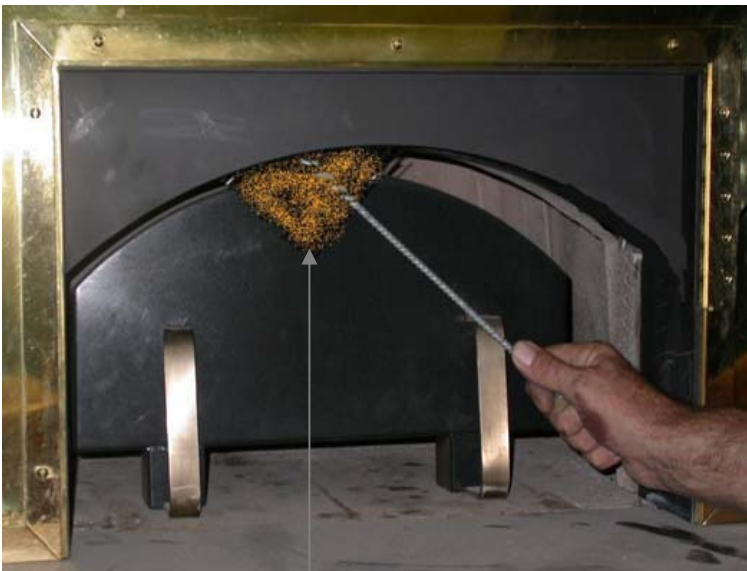
1. The Spigot area of the oven, above the mouth or door of the oven, Should be cleaned of build-up at least once per week (*7 days*).

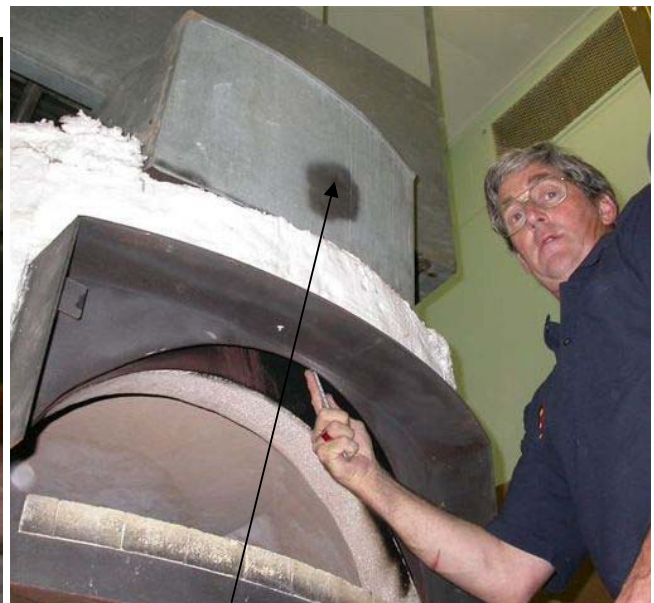
Spigot Cleaning Brush

Be sure to clean the spigot thoroughly, all the way to the top of the spigot adapter.

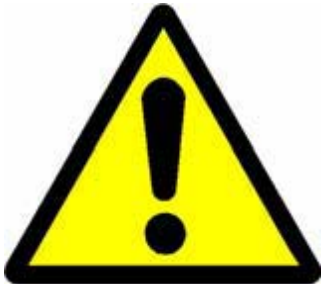
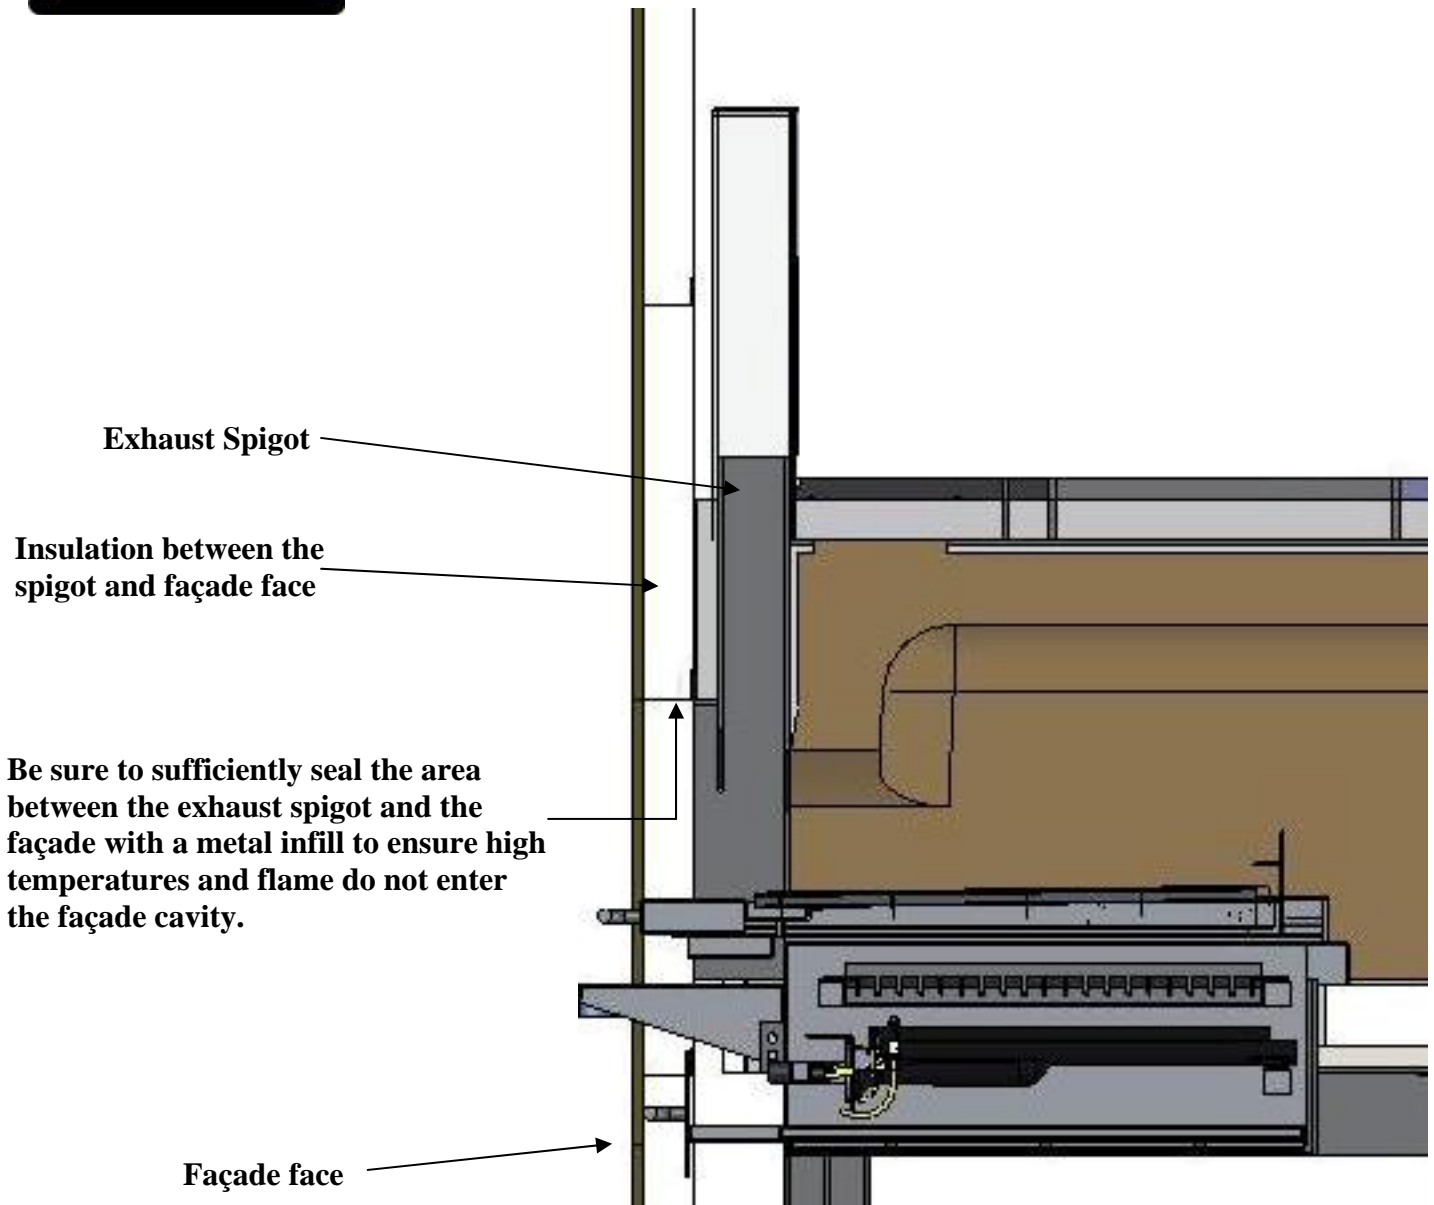
Façade Installation Warning

An important area to be aware of is directly in front of the exhaust spigot of the oven. If the facade protrudes from the spigot there may be an area between the spigot/lintel and the facade which is left uncovered and vulnerable to soot and grease build-up. This area is commonly overlooked when constructing the oven facade and if not sufficiently sealed creates a **fire hazard**.

Solution: Ensure that the area above the oven door and façade is fully sealed with a fire proof material (*refer diagram on page 6*)

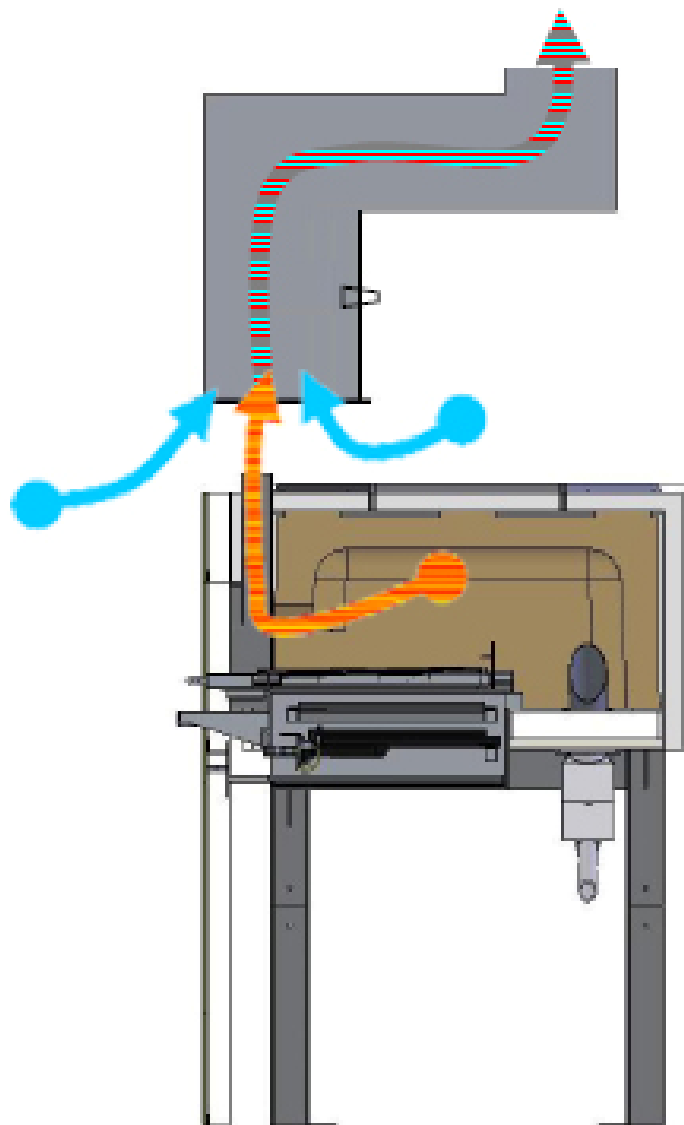
Potential Improvement 1 (*Recommended*)

The installation of a canopy has several benefits.

1. Easy access to filters for regular cleaning
2. Visible break between spigot and canopy to alert if flash fire should occur
3. Better access to oven spigot to allow for regular cleaning
4. Allowance for an independent Tyco/Wormald/Ansul wet chemical fire protection system to be fitted

Page 6 outlines one potential improvement to the ducting system to address the above mentioned issues. These improvements are recommendations only. Contact Doughpro Ovens head office for further information.
